Firestopping Report Summary

Open Issues	130
Closed Issues	179
Facility Issues	27

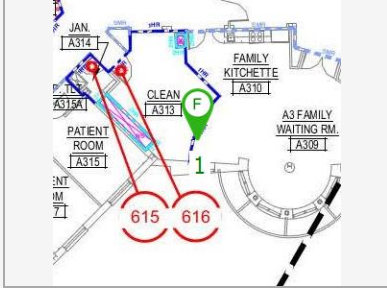
1 RESOLVED

Status: Closed
Description: 2"x4" Scab patch. Needs to be removed. Scab patch is complete.

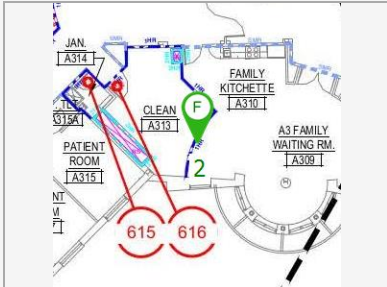
2 RESOLVED

Status: Closed
Description: 1" Open hole. Unsealed

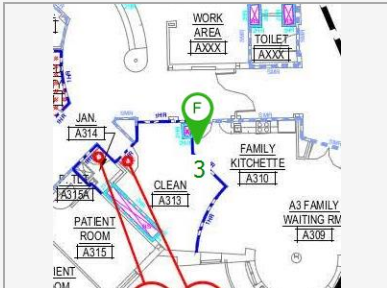
3 RESOLVED

Status: Closed
Description: Improperly sealed. Material needs to be removed and fire stopped.

Status: Closed
Description: Mixed materials improperly sealed. Materials have been removed and fire stopped.

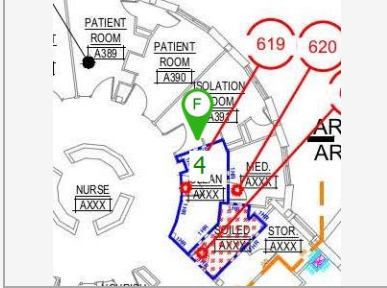
4	RESOLVED	
Building: Main Floor: 3

Status: Closed Description: 3/4" Flex cable. Unsealed
	<div style="display: flex; justify-content: space-around;"> <div style="text-align: center;"> Before:

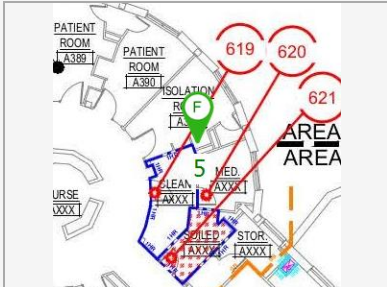
5	RESOLVED	
Building: Main Floor: 3

Status: Closed Description: 3/4" Flexible Conduit. Unsealed
	<div style="display: flex; justify-content: space-around;"> <div style="text-align: center;"> Before:

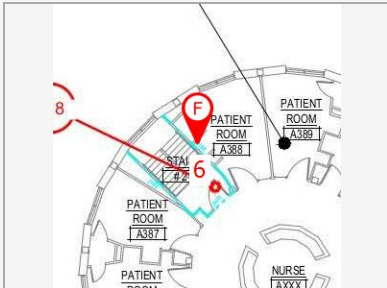
6	NOT RESOLVED	
Building: Main Floor: 3

Status: Open Description: Flexible steel conduit unsealed. Status: Open Description: 1" steel conduit penetrating rated concrete wall assembly. No access due to hard ceiling in bathroom.
	<div style="display: flex; justify-content: space-around;"> <div style="text-align: center;"> Before:

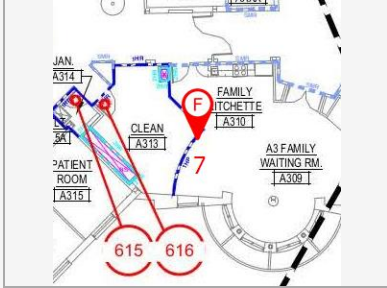
7 NOT RESOLVED

Status: Open
Description: Head of wall. Improperly sealed. Incorrect caulk.

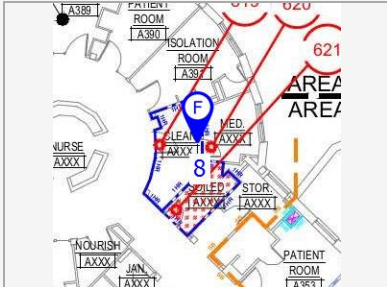
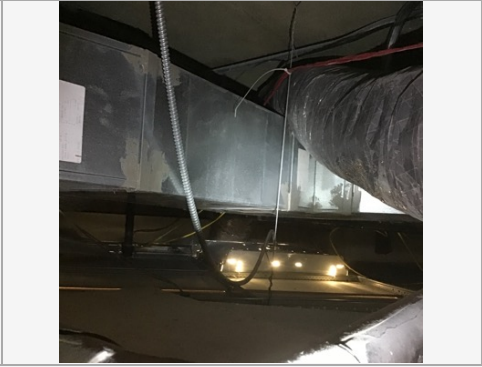
8 FACILITY ISSUE

Description: Rated wall does not go to deck.

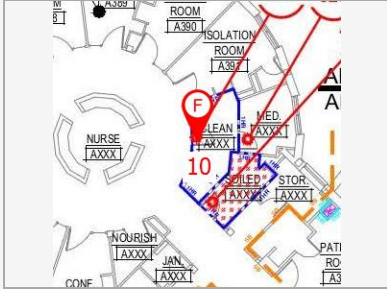
10 NOT RESOLVED

Status: Open
Description: Scab patch needs to be removed and wall repaired around duct.

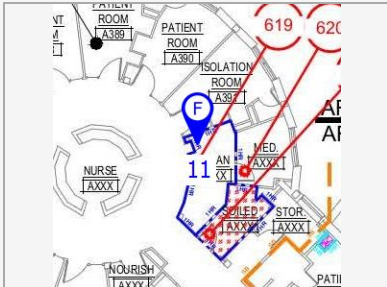
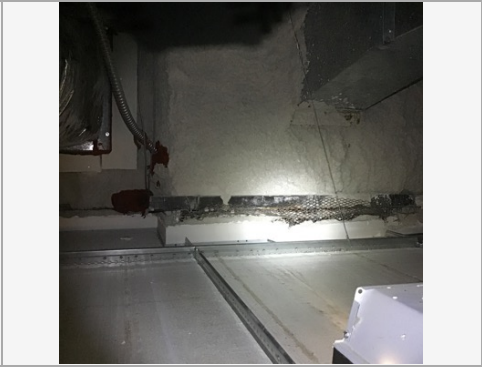
11 FACILITY ISSUE

Description: Voids in plaster

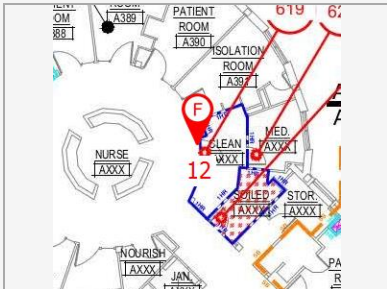
12 NOT RESOLVED

Status: Open
Description: Patch needs to be removed from around duct.

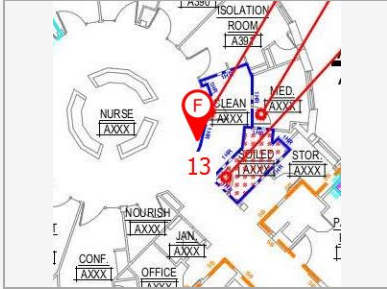
13
NOT RESOLVED

Status: Open
Description: 12"x14" Scab patch needs to be removed. Mixed multi and 3- 1/2" Cooper pipes going through.

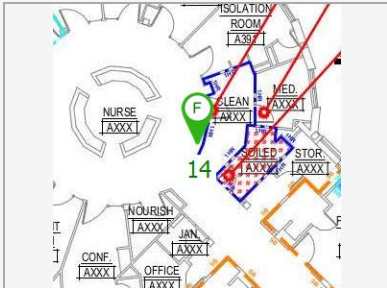
14
RESOLVED

Status: Closed
Description: 1/2" Sleeved cables. Incomplete seal.

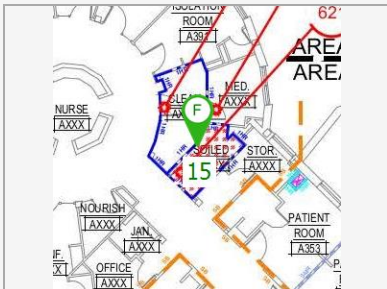
15
RESOLVED

Status: Closed
Description: 2" Metallic pipe. Unsealed

Status: Closed
Description: 3/4" Conduit. Unsealed

Status: Closed
Description: 3/4" Open sleeve. Unsealed

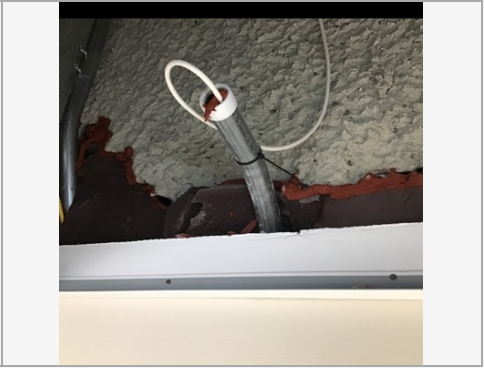
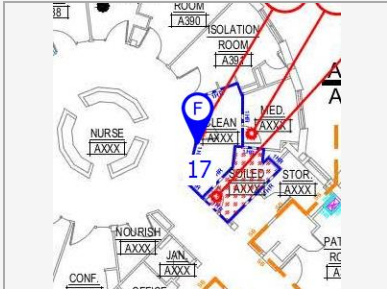
17
FACILITY ISSUE

Description: 8" x 26" hole in rated wall needs repair. 1/4"-1/2" drywall with plaster on top. Recessed behind 5/8" drywall.

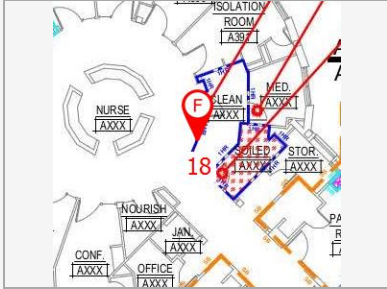
18
NOT RESOLVED

Description: J box cover needed.

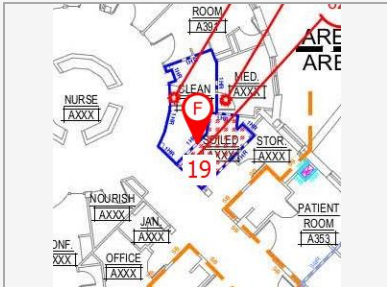
19
NOT RESOLVED

Description: Head of wall. Improperly sealed. Wrong caulk

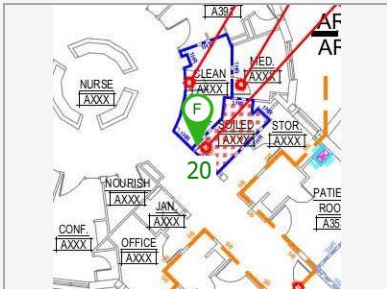
20
RESOLVED

Description: 3/4" Conduit. Unsealed
